Investigation of the Performance of the New Orleans Flood Protection Systems in Hurricane Katrina on August 29, 2005

Volume I: Main Text and Executive Summary

**Final Report
July 31, 2006**

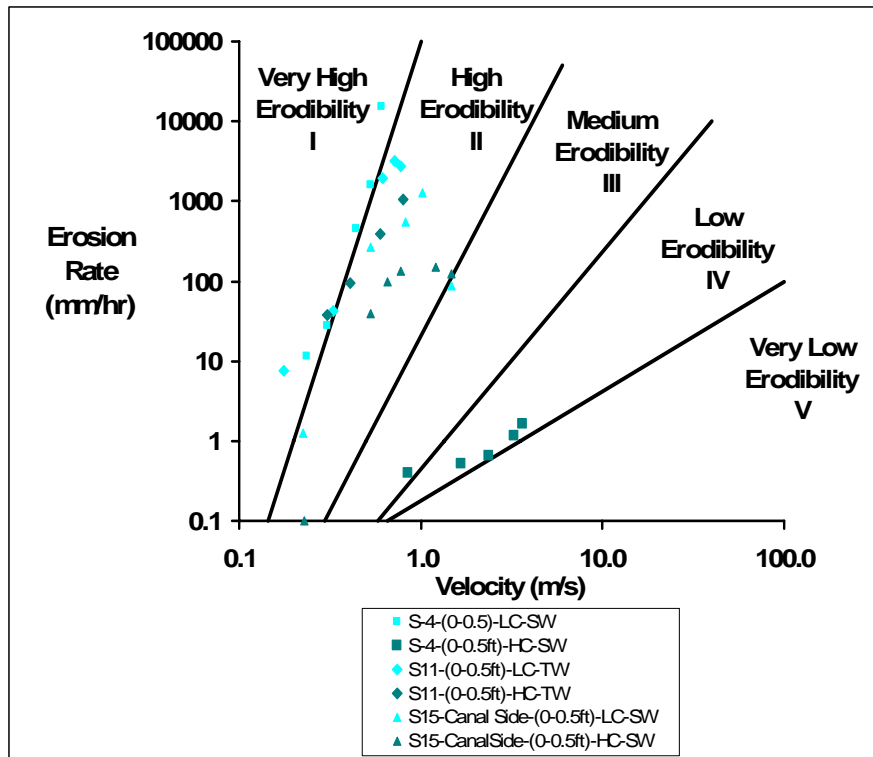
Several of the bag samples were tested at two extreme compaction efforts: 100% Modified Proctor and 1.6% Modified Proctor. Because the low and high compaction samples originated from the same bag of collected soil, it is reasonable to assume that the samples are very similar. The EFA tests results aimed at identifying the influence of the compaction effort are isolated in Figure 9.42. Sample S4 shows a major influence of the compaction effort on the erodibility. Indeed, the low compaction sample is at the border between Category 1 and Category 2 (very high to high erodibility) while the high compaction sample is at the border between Category 4 and Category 5 (very low to low erodibility). However, Samples S15 and S11 do not show much difference between the high compaction and the low compaction.

Figure 9.42: Influence of compaction on erodibility.

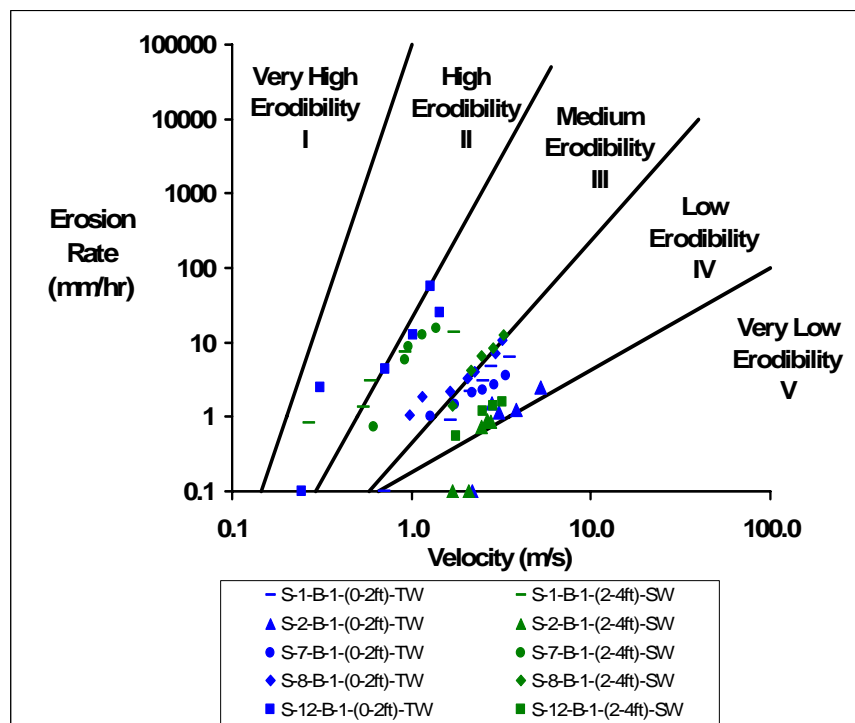
The EFA tests results for the tests aimed at identifying the influence of the water salinity are isolated in Figure 9.43. Conclusions are difficult to draw because the samples may not be from the same soil. One sample (S8-B1) actually was made of two separate layers which had two different erosion functions and lead to two EFA curves for the same Shelby tube.

Figure 9.43: Influence of water salinity on erodibility.

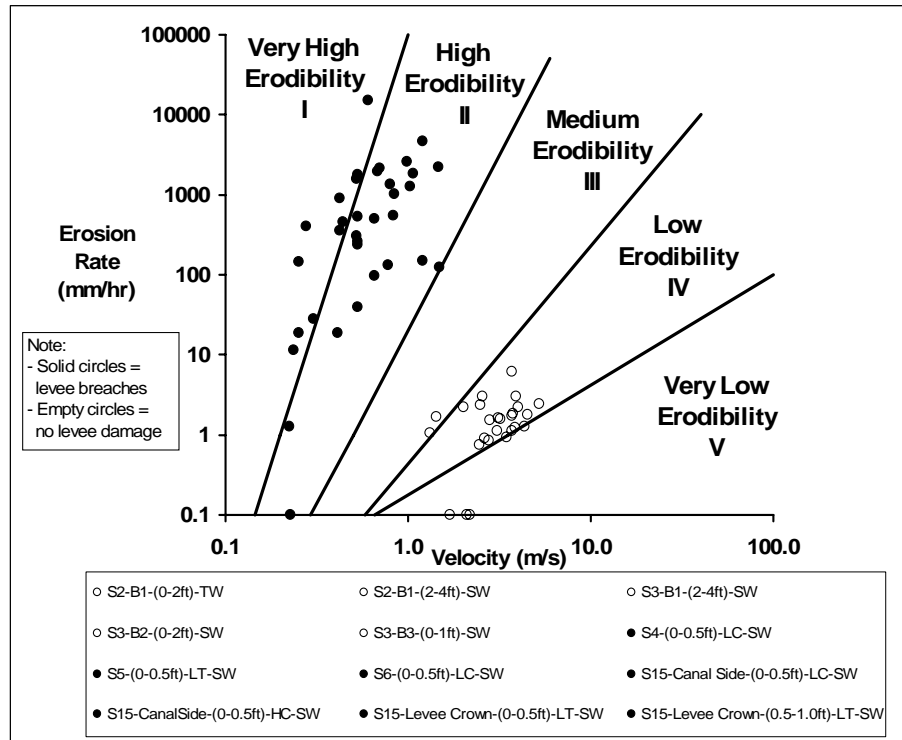
In an effort to correlate the results of the EFA erosion tests with the behavior of the levees during overtopping flow, Figure 9.44 was prepared. It seems reasonably sure that the levees at sites S4, S5, S6, and S15 were overtopped and failed. At the same time it seems reasonably sure that the levees at sites S2, and S3 were overtopped and resisted remarkably well. The dark circles on Figure 9.44 correspond to samples taken from levees that were overtopped and failed by erosion while the open circles correspond to samples taken from levees that were overtopped and held up well during that overtopping.

Figure 9.44 shows a definite correlation between the EFA tests results and the behavior of the levees during overtopping. Figure 9.45 was generated from Figure 9.44 as a levee guideline for erosion resistance during overtopping. It is suggested that such EFA erosion tests should be used in the future to predict levee behavior and ensure erosion resistance to overtopping. In addition, this type of testing can be performed on an increased variety of soils, and with varied compaction conditions, to develop generalized relationships

Figure 9.44: EFA test results and overtopping levee failure/no failure chart.

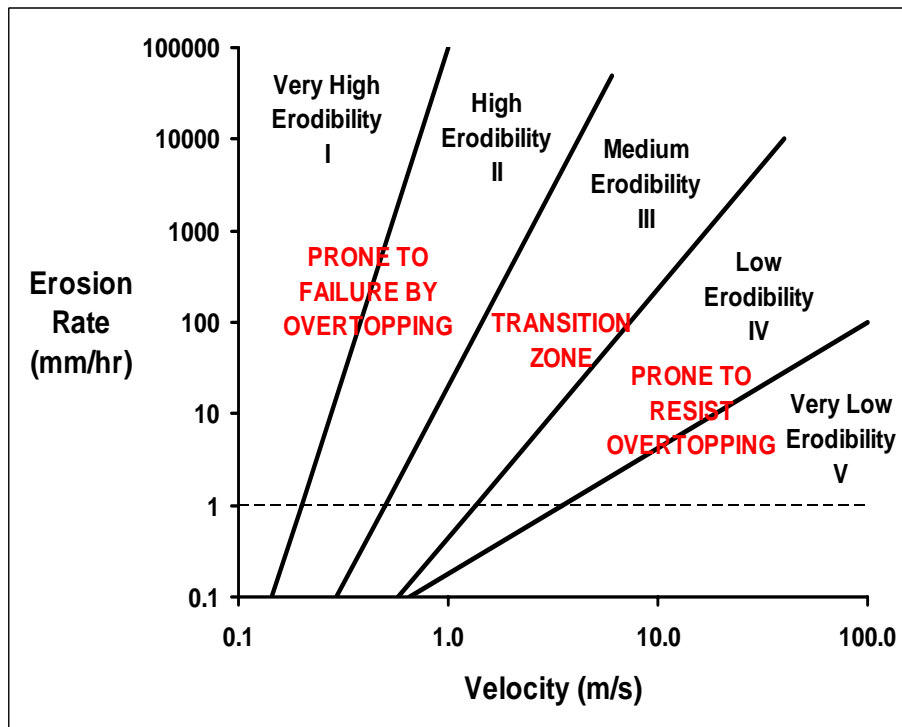
Figure 9.45: Proposed guidelines for levee overtopping.

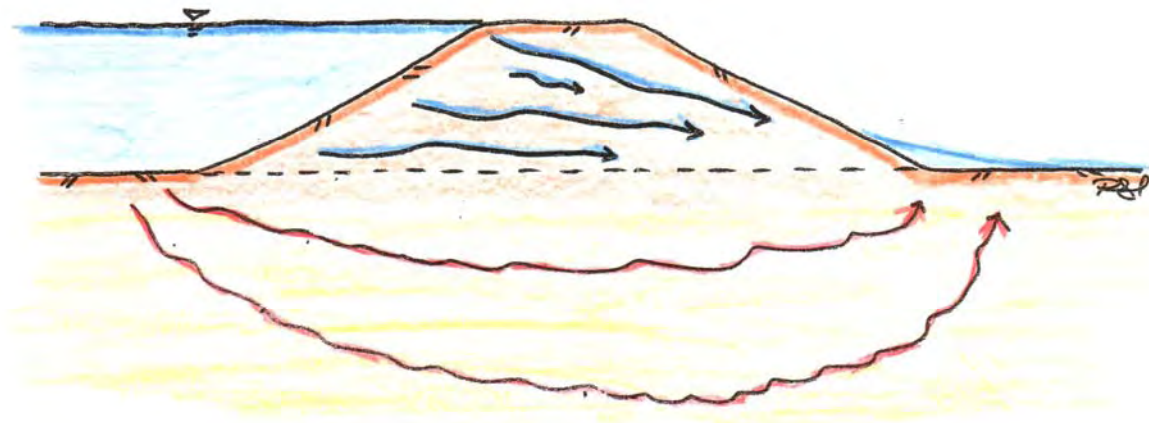
Underseepage/Instability – As shown in Figure 10.1 (red lines), if the underlying foundation materials that support the levee are adequately permeable, water can quickly travel through these porous materials as the water head differential between the outboard and inboard sides of the levee increases. This underseepage raises the pore pressures within the soils at the inboard side, and this in turn reduces the shear strengths of these soils. This can result in catastrophic failure by means of resultant slope instability (as described in the previous section).

Erosion and Piping – As shown in Figure 10.1 (blue lines), erosion and piping occurs when the localized hydraulic gradient becomes large enough to “pull” soil grains from their location, and when there is no soil on that soil’s down-flow side that can “filter” these soil grains and thus hold them in place. Erosion and piping can be sub-divided into two sub-classes as:

Figure 10.1: Underseepage in highly permeable underlying foundation materials (red lines) can result in the catastrophic failure of the levee in that once the foundation materials have been eroded, the levee (which may be completely undamaged) has no underlying support and falls into the resulting void and essentially washes away.

Internal erosion and piping (blue lines) occurs in levee materials that have high permeabilities (such as sand and gravel) and allow for water to rapidly flow from high pressure areas to low pressure areas. As the water flows through the levee, smaller/finer soil particles are “washed” out of the levee resulting in the internal erosion of the levee. Enough internal erosion of the levee can lead to the collapse and subsequent “wash-out” of the levee.

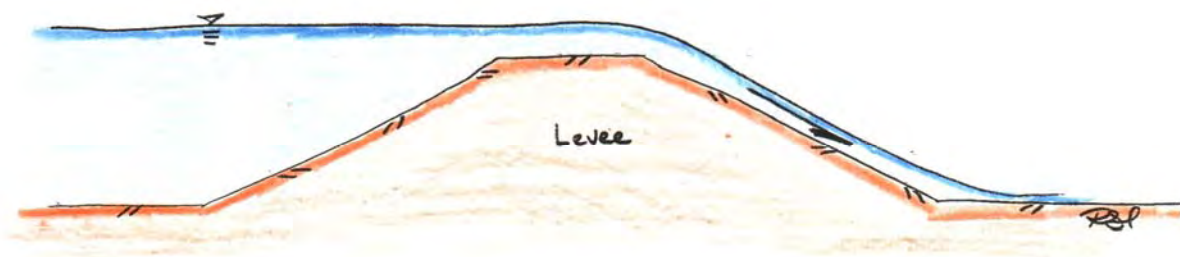
(a) Overtopping – As shown in Figure 10.2, overtopping occurs when the water level on the outboard side of the levee exceeds the crest elevation of the levee. The inboard side of the levee acts as a spillway for the overtopping water and damage is inflicted on the levee as a result of water scour. Levees are not generally designed for overtopping and as a result, if overtopping does occur, they are can be highly susceptible to catastrophic failure unless overtopping duration and intensity are limited and erosion-resistant materials are used to construct the levee (or unless erosion protection, in the form of “armoring” is applied to the exposed crest and faces of the levee.) As water passes over the top of the levee, its velocity increases as it runs down the back side, and the erosive shear force of the water increases with this increase in velocity.

Figure 10.2: Overtopping occurs when the water level on the outboard side of the levee exceeds the crest elevation of the levee. The inboard side of the levee acts as a spillway for the overtopping water and damage is inflicted on the levee as a result of water scour.

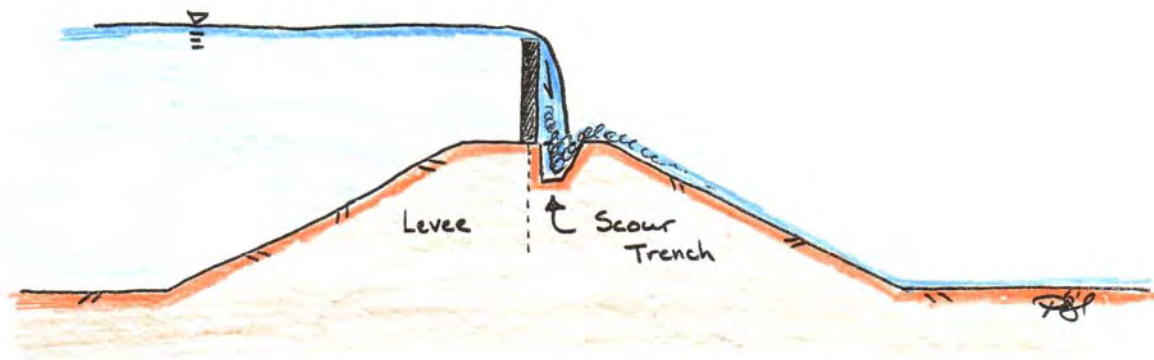
(b) Sharp Overtopping and Jetting – This is more likely to occur on levees with floodwalls. As shown in Figure 10.3, jetting occurs when the water level on the outboard side of the levee exceeds the top of wall elevation for structural walls that are founded within the earthen levee. Unlike overtopping of a conventional earthen levee, the floodwall acts as a weir and water falling over the wall impacts the levee in a concentrated stream that is much more energy intensive than conventional overtopping. For typical New Orleans floodwalls, the water impact velocities are on the order of 6 to 8 m/s. Levees are not generally designed for overtopping and jetting and as a result, if overtopping and jetting does occur, a deep scour trench can rapidly develop against the land-side face of the floodwall. This reduces the earth pressure providing lateral support for the wall, making the wall highly susceptible to potential catastrophic lateral failure (when pushed by the water pressures on its outboard side). This erosive trenching can be prevented by installing “splash-pads”, coarse rip-rap, or other energy dissipating devices at the inboard side toe of the floodwall, and the use of highly erosion-resistant materials to construct the crown section of the levee is also advisable here.

Figure 10.3: Jetting occurs when the water level on the outboard side of the levee exceeds the top of wall elevation for structural walls that are founded within the earthen levee. Unlike overtopping of a conventional earthen levee, the floodwall acts as a weir and water impacts the levee in a concentrated stream that is much more energy intensive than conventional overtopping.

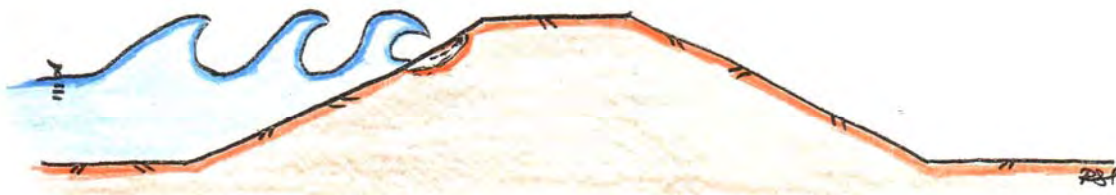
(d) Wave Impacts – As shown in Figure 10.5, wave impacts can cause significant erosion to levee faces. Wave-induced erosion consists of run-up (sloshing up and down of water as a result of staggered wave arrival) and “mini-jetting” when the crest of the waves breaks on the levee face. Levees that are anticipated to be impacted by waves are generally designed with armoring to prevent damage from wave impacts.

Figure 10.5: Wave impacts can cause significant erosion to levee faces. Wave-induced erosion consists of run-up (sloshing up and down of water as a result of staggered wave arrival) and “mini-jetting” when the crest of the waves breaks on the levee face.

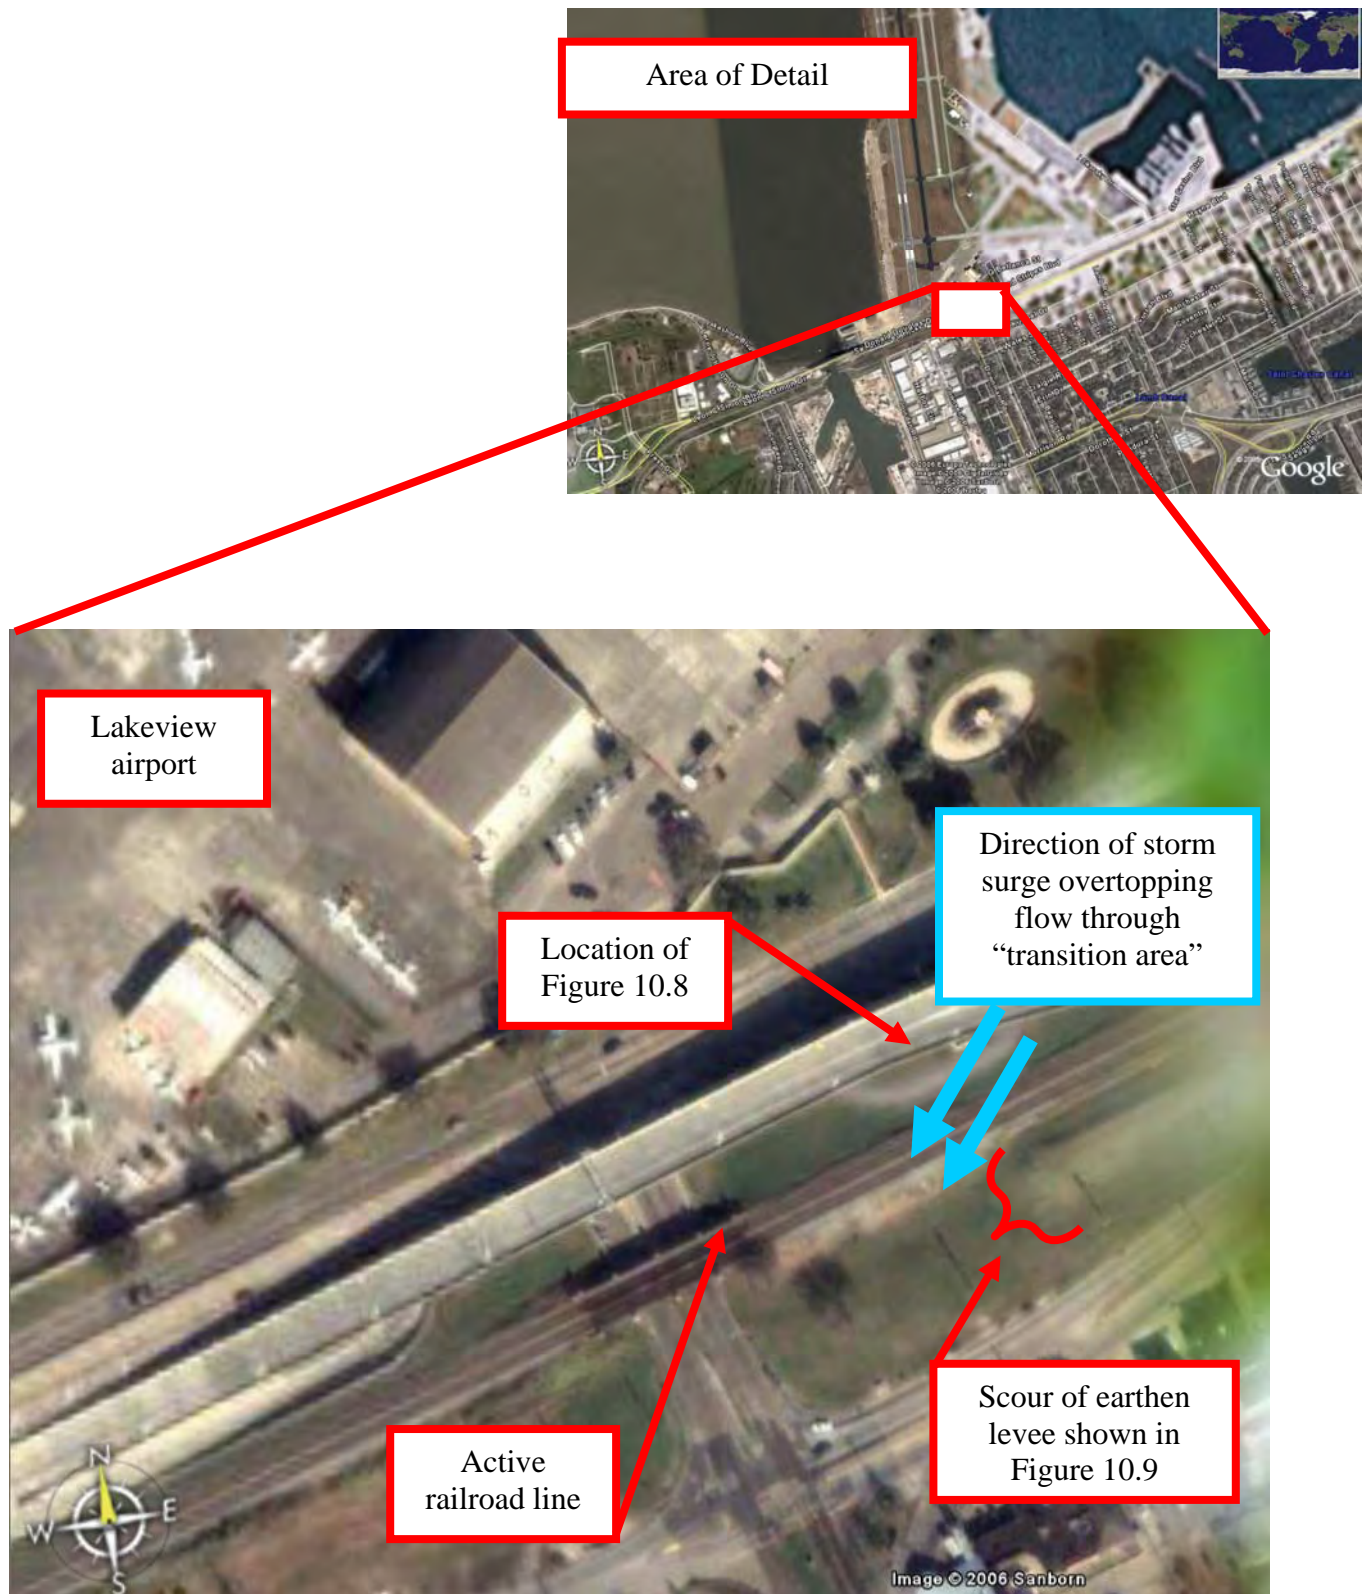
Figure 10.7: Storm-surge induced overtopping traveled through the granular gravel ballast for the railroad line and eroded the railroad line embankment, which served as a transition levee between the concrete floodwall and the earthen levee shown in Figure 10.8.

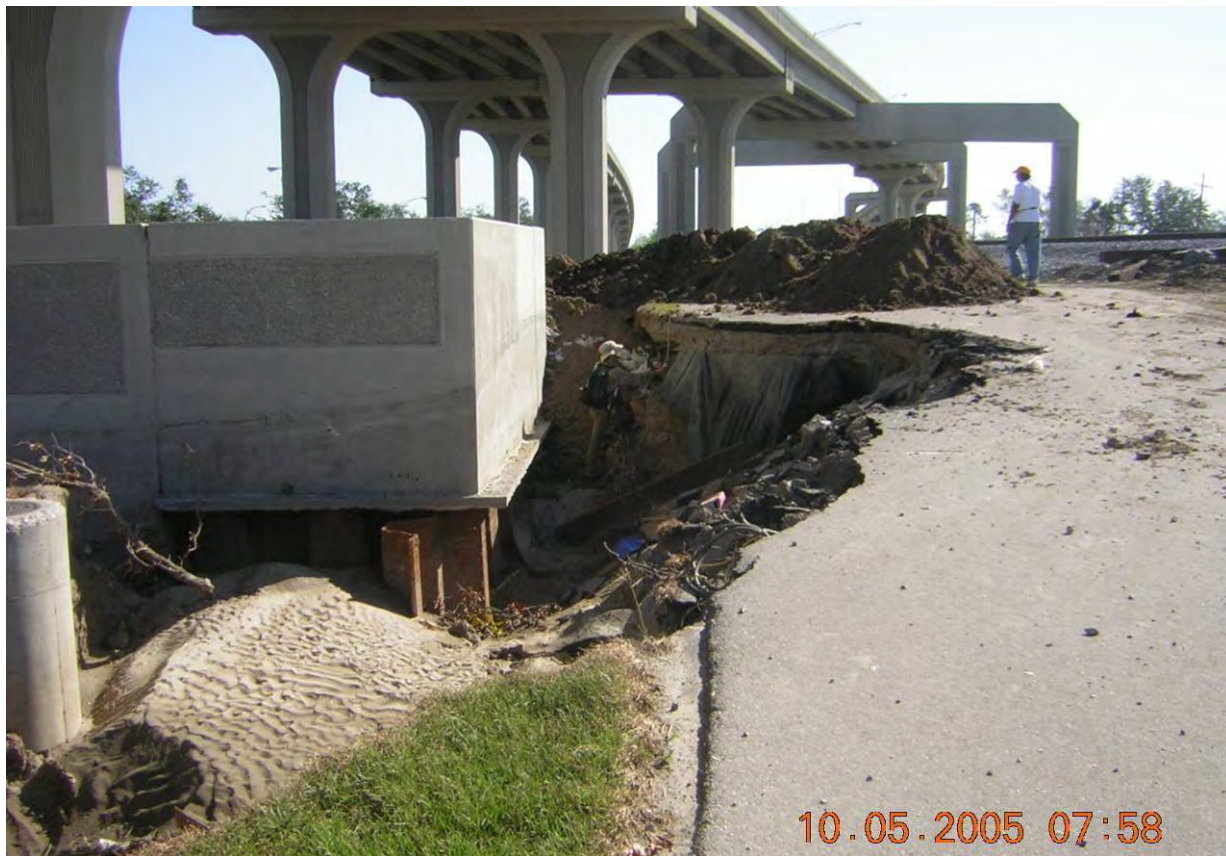
Figure 10.8: Lakefront levee near the Lakefront Airport at location 1 (as indicated on Figure 10.7) where overtopping occurred and significant scour around the floodwall was observed.

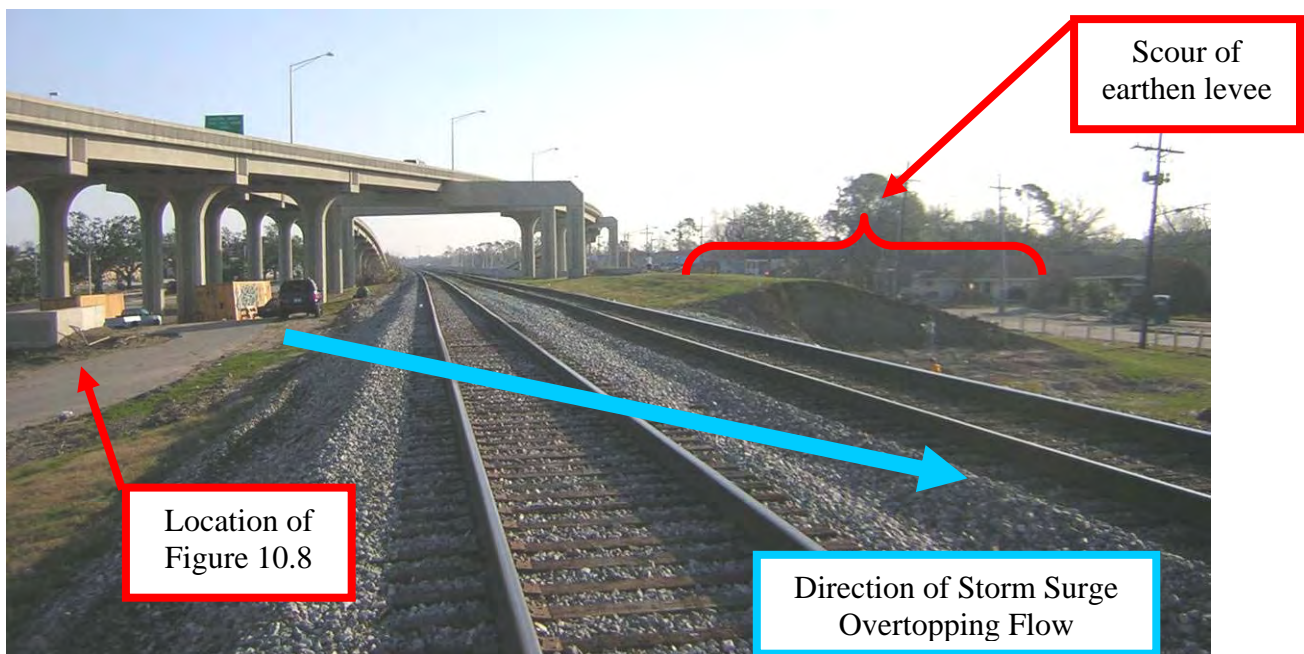
Figure 10.9: Significant erosion was observed on the levee behind the floodwall shown in Figure 10.8. The storm surge overtopped the floodwall and railroad ballast and failed the earthen levee.

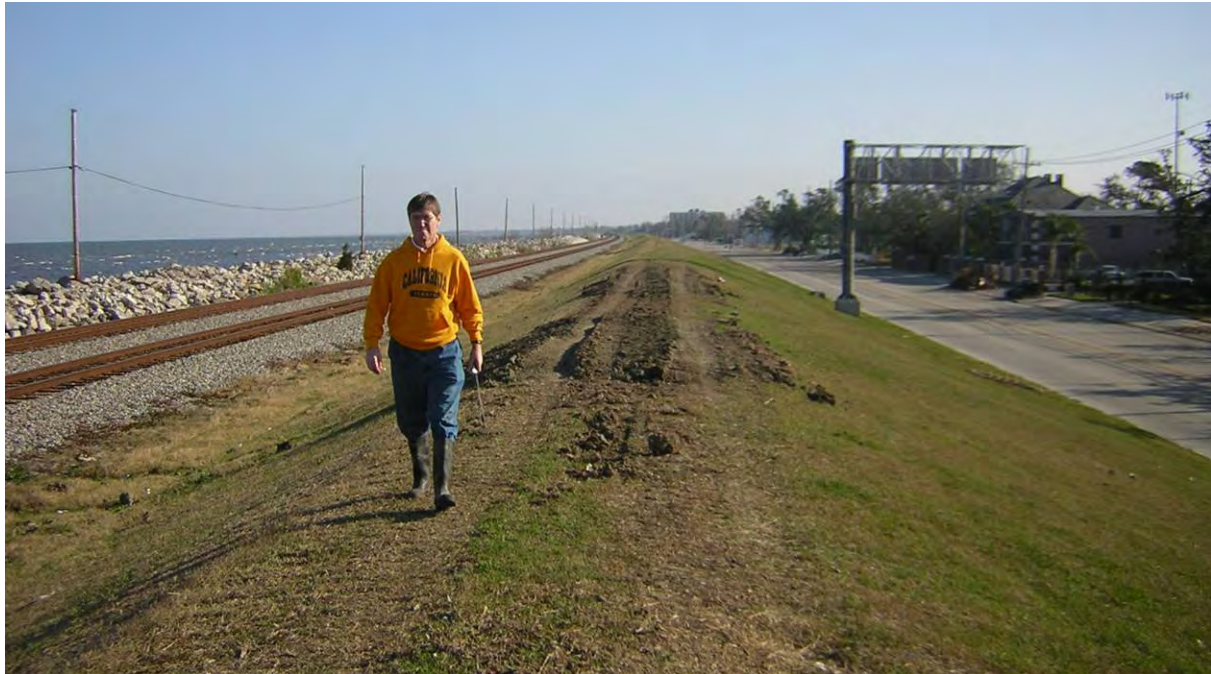
Figure 10.10: Lakefront levee at location 2 (as indicated on Figure 10.6) where minor overtopping occurred. These levees performed well and only minor, surficial damage was observed.

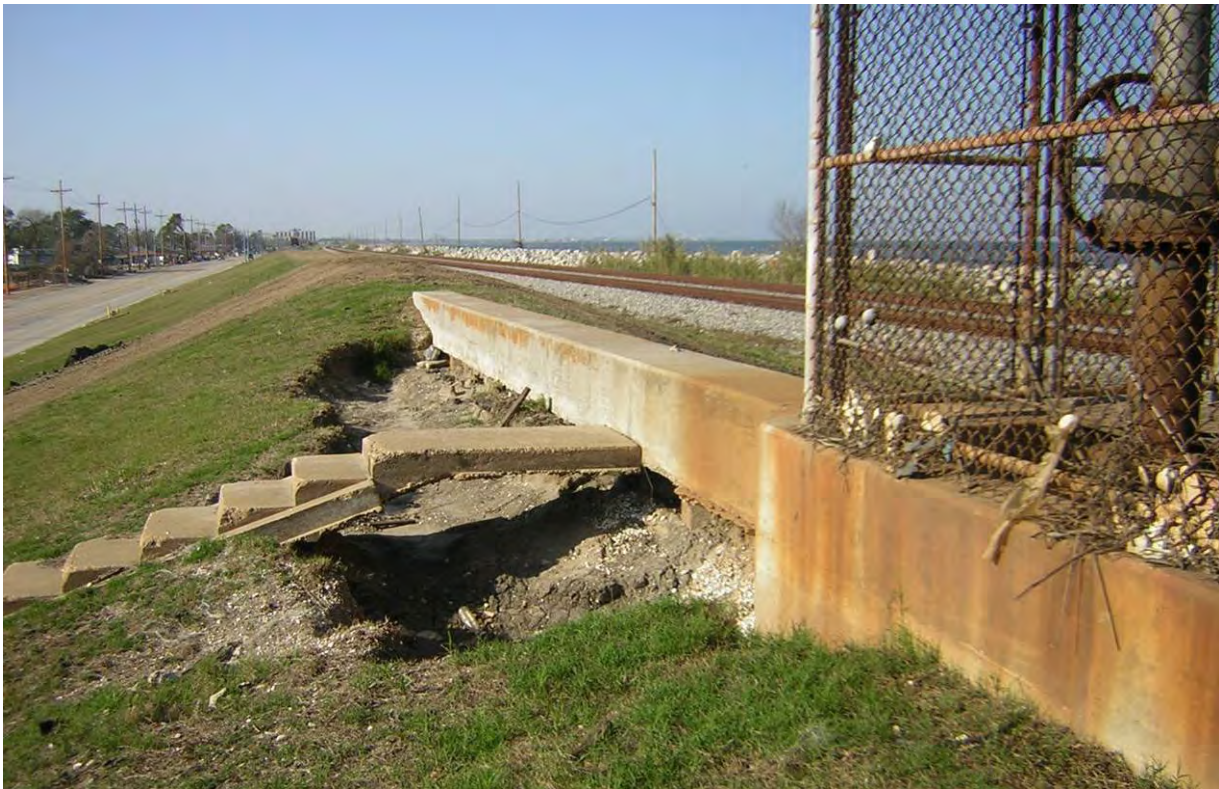
Figure 10.11: Observed scour at the Jahncke Pump Station outfall structure (location 2 as indicated on Figure 10.6). Scour was limited to areas of soil-structure interfaces, and no full breach occurred.

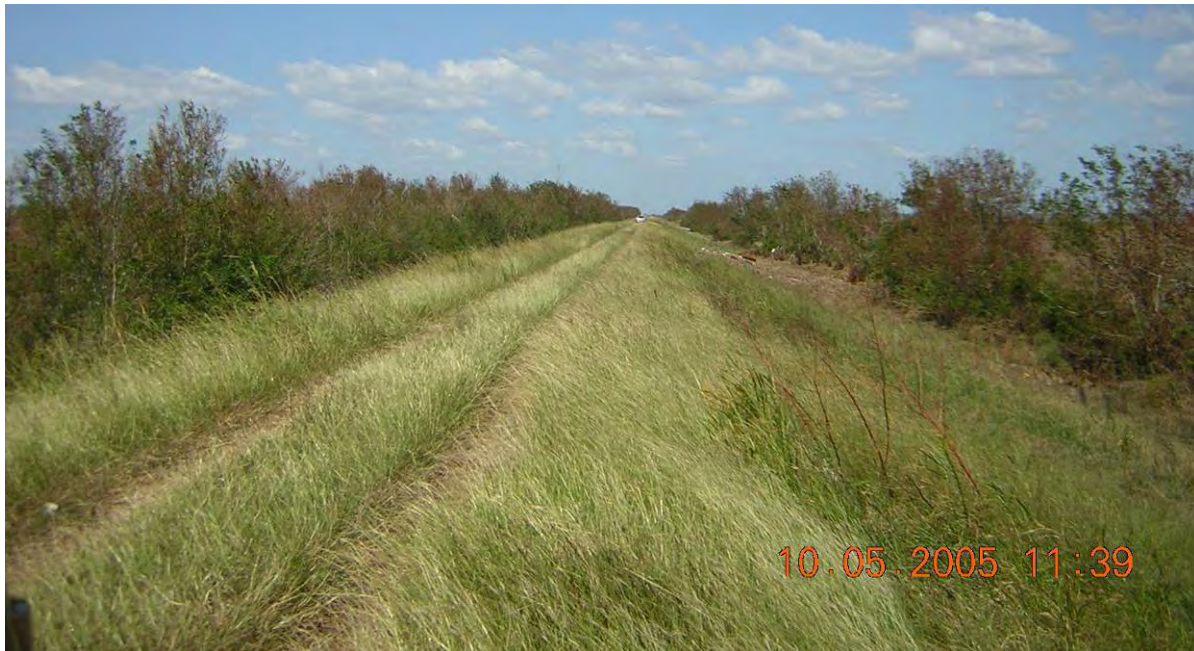
Figure 10.12: Condition of levees east of HWY 11 (location 3 on Figure 10.6) in October 2005. These levees performed exceptionally well and were not eroded during Hurricanes Katrina or Rita.

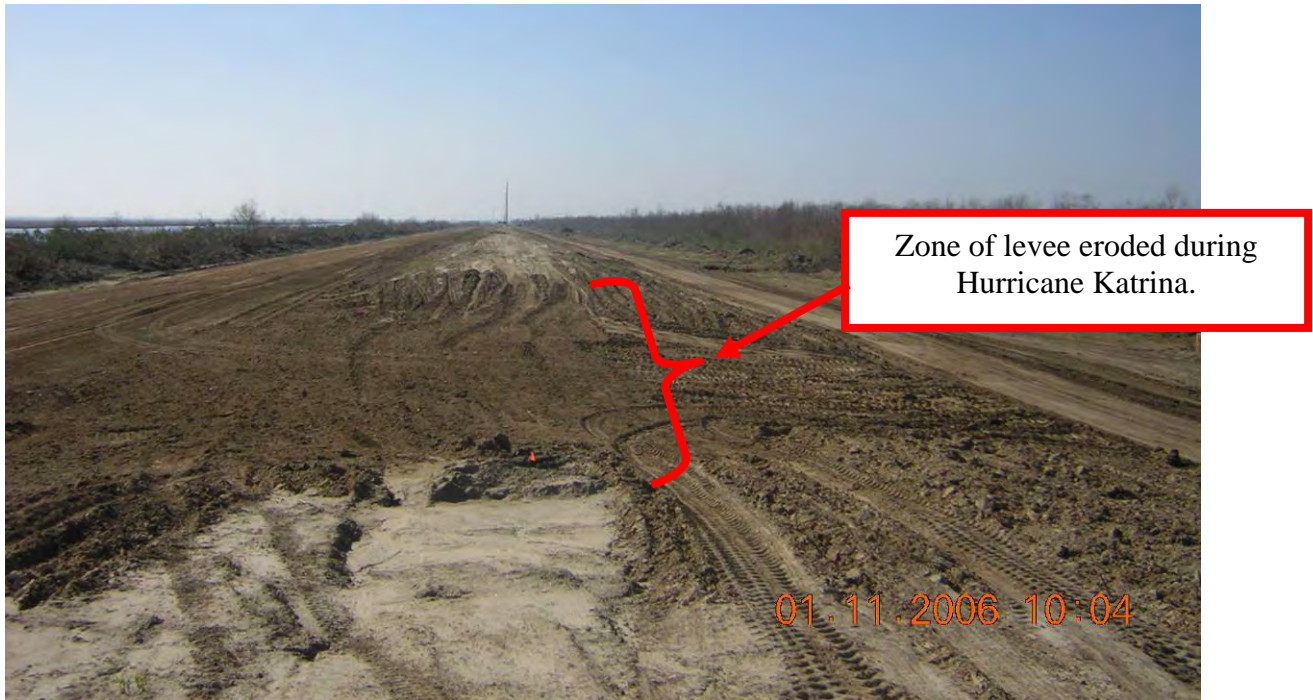
Figure 10.14: Zones of earthen levees at the southeast corner of the New Orleans East polder (location 4 on Figure 10.6) were washed out during Hurricane Katrina allowing water to rush in.

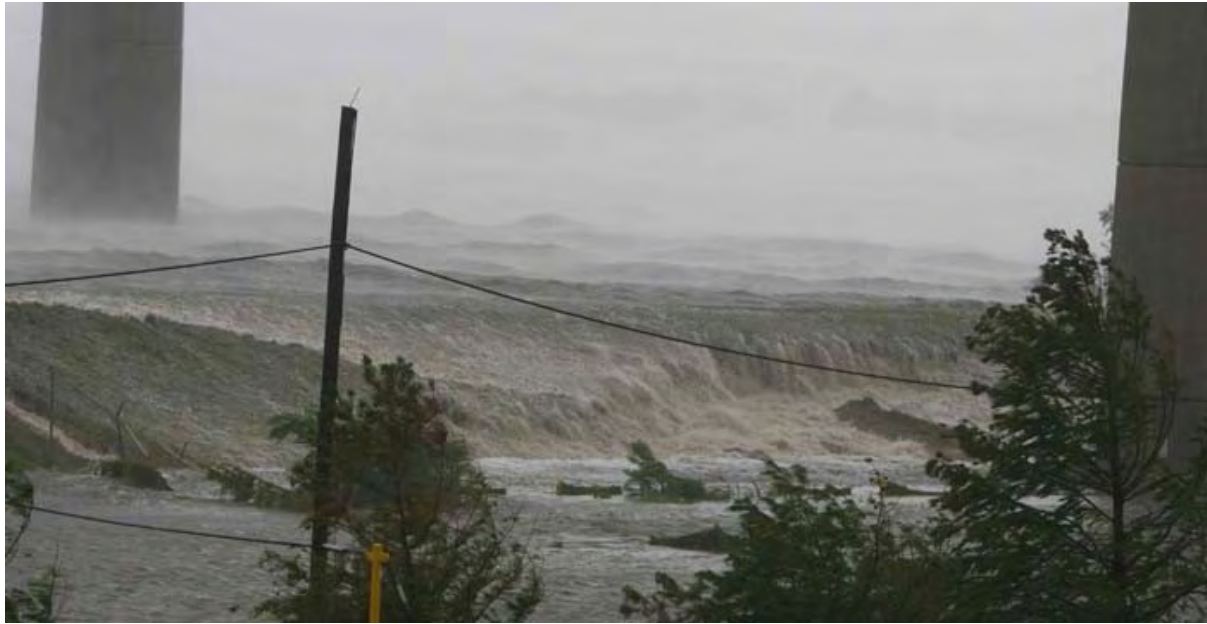
Figure 10.16: Photographs (location 5 on Figure 10.6) captured by a security camera at the Entergy Michoud Generating Plant beneath Route 47, on the IWW/MRGO show active overtopping during Hurricane Katrina.

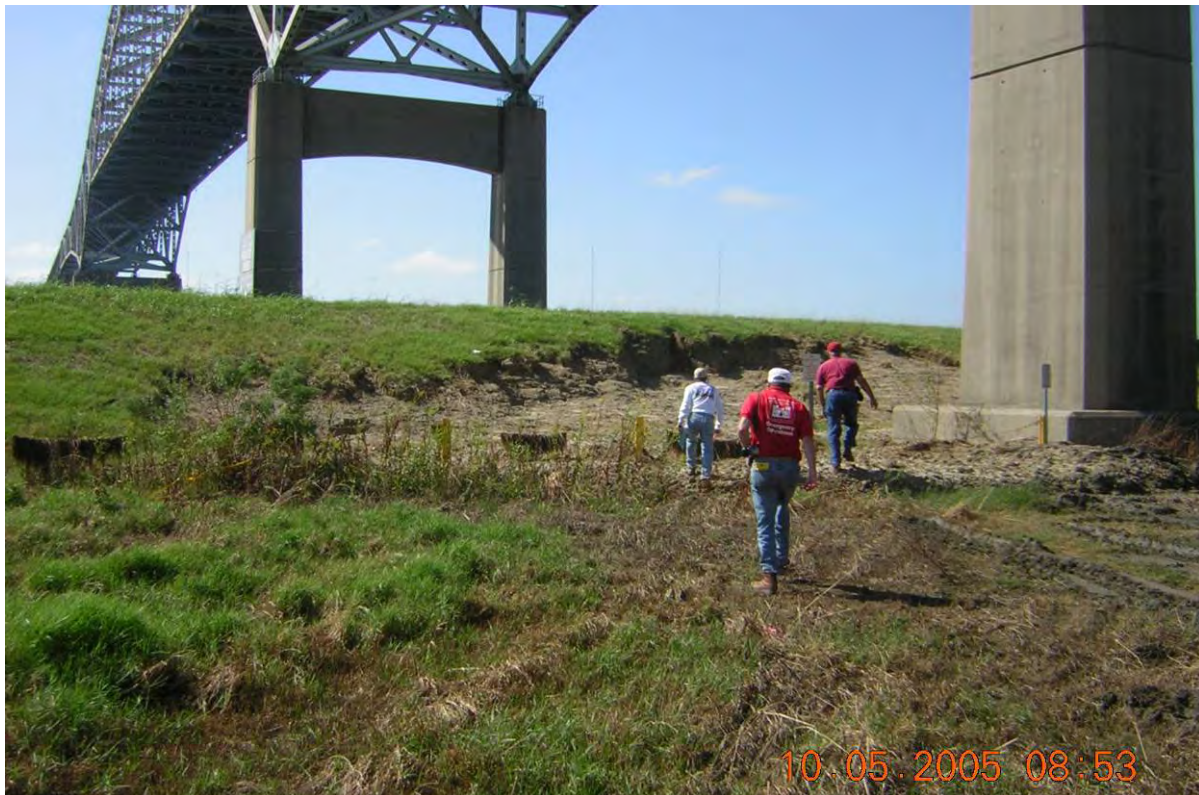
Figure 10.17: Post Hurricane Katrina view of the earthen levee shown in Figure 10.16. Only minor damage on the protected side was observed, with the majority of the damage a result of wave reflection from the bridge abutment at the right-hand side of the picture.

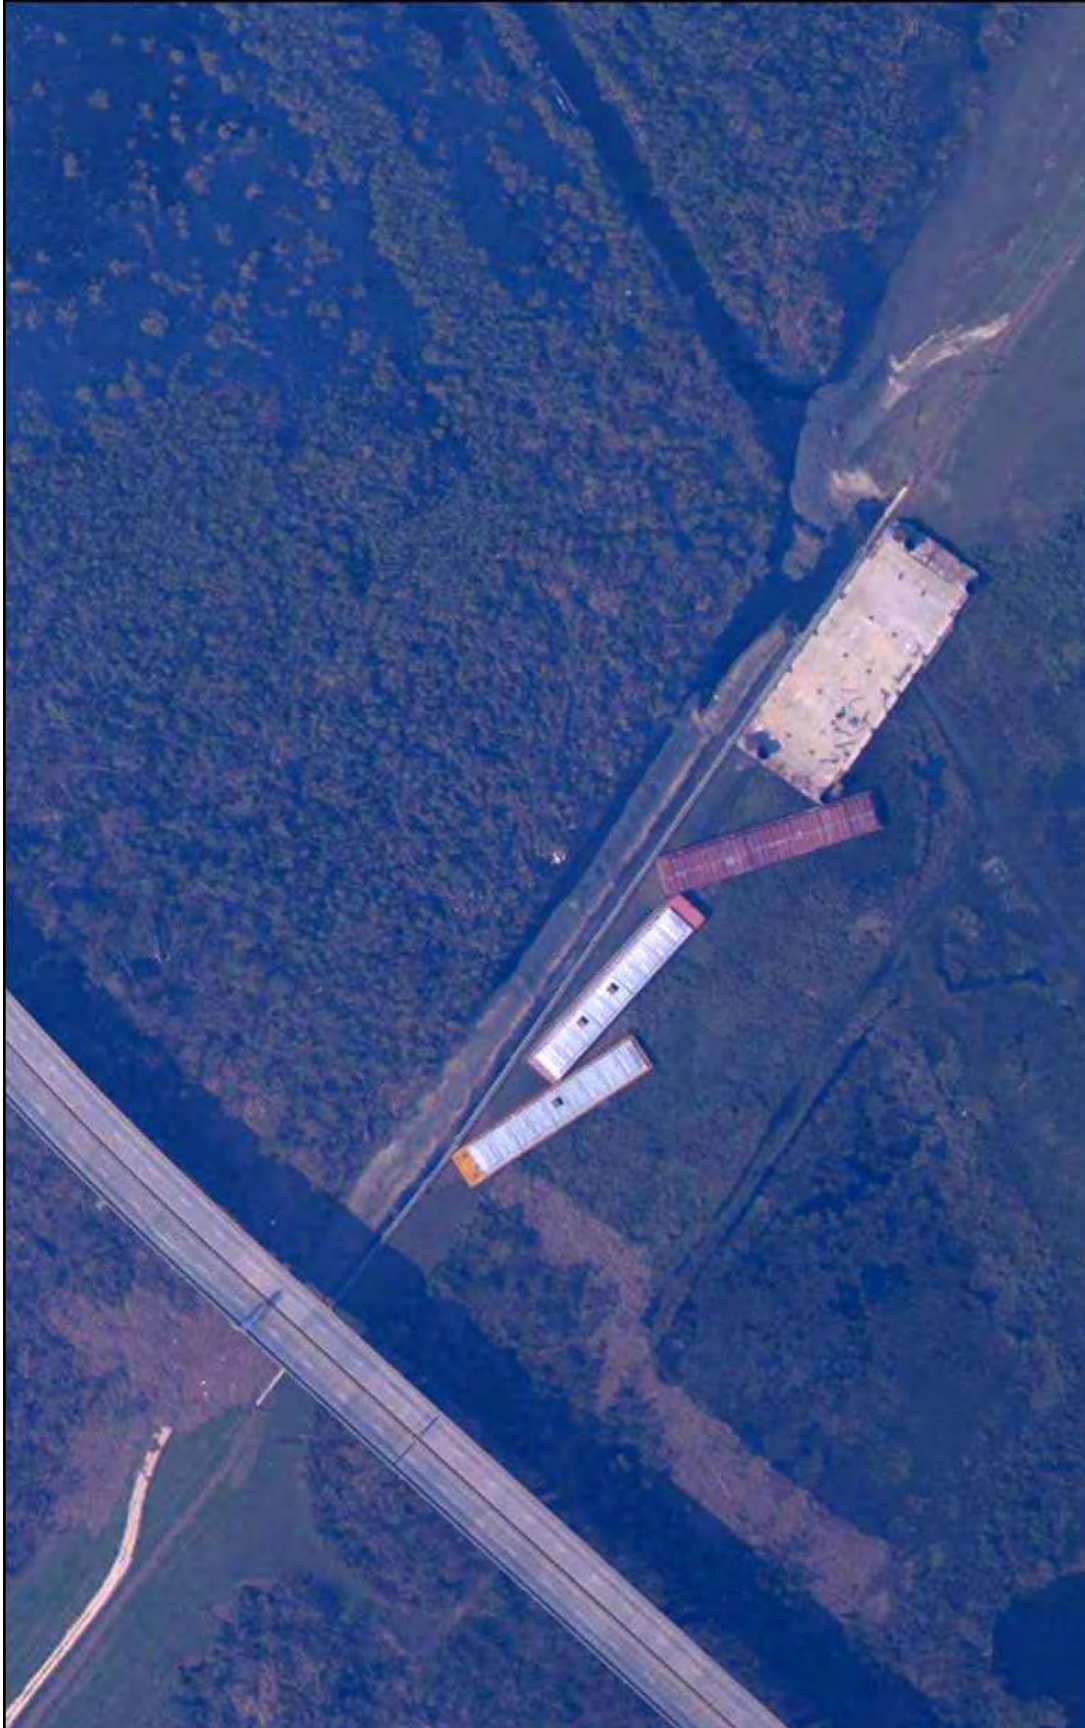
Figure 10.18: The presence of a concrete floodwall beneath the Hwy 47/Parish Road Bridge acted as a weir during the overtopping stages of the storm and “sucked” in nearby barges. Scour can be observed behind the concrete floodwall, but there is only minor scour damage visible at the earthen levee/concrete floodwall transition. Overall, this system performed well (also considering the impact associated with the barges).

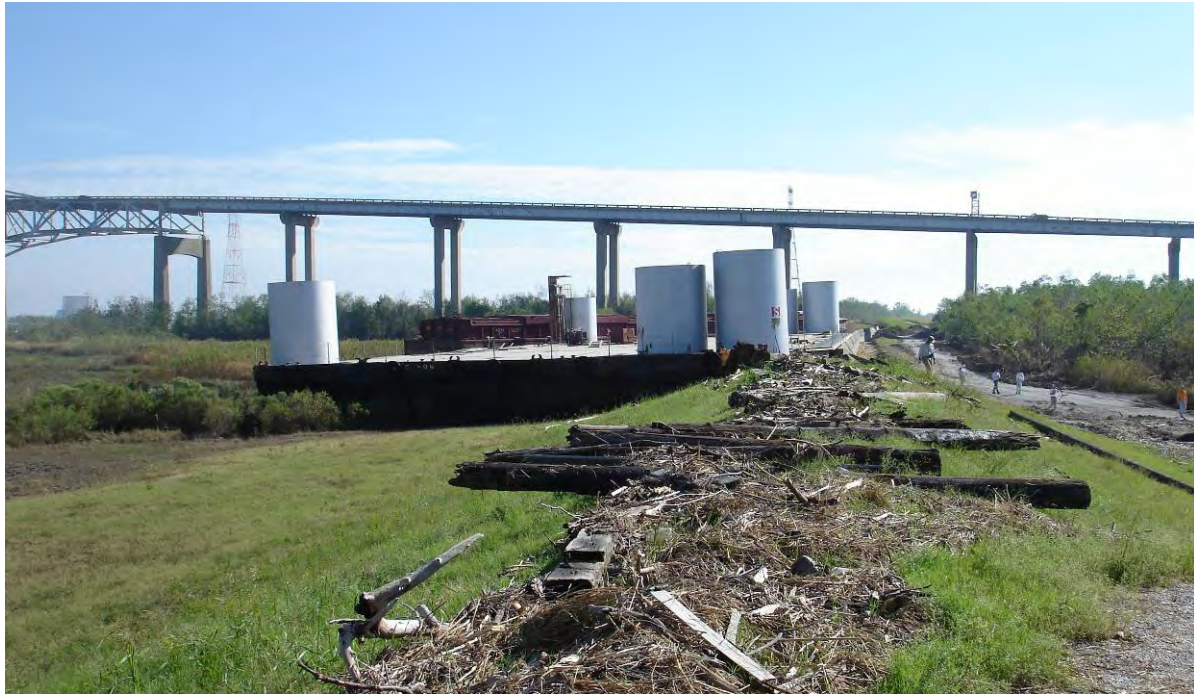
Figure 10.19: Woody debris and steel barges “washed up” on the southern ICWW/MRGO levee just west of Route 47 (location 6 on Figure 10.6). This is a side view from the aerial photograph presented in Figure 9.24.

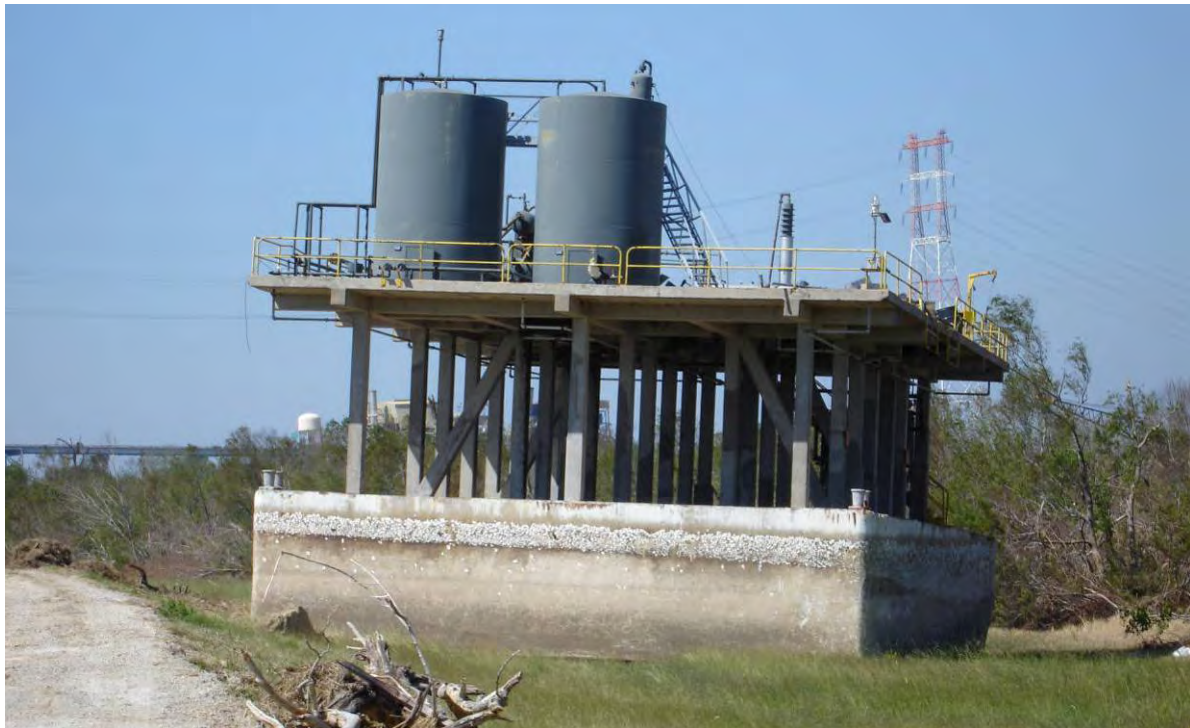
Figure 10.20: A gas processing barge “washed up” on the southern IWW/MRGO levee just east of Route 47 (location 6 on Figure 10.6). This levee was also overtopped and was not significantly damaged by the barge impact.

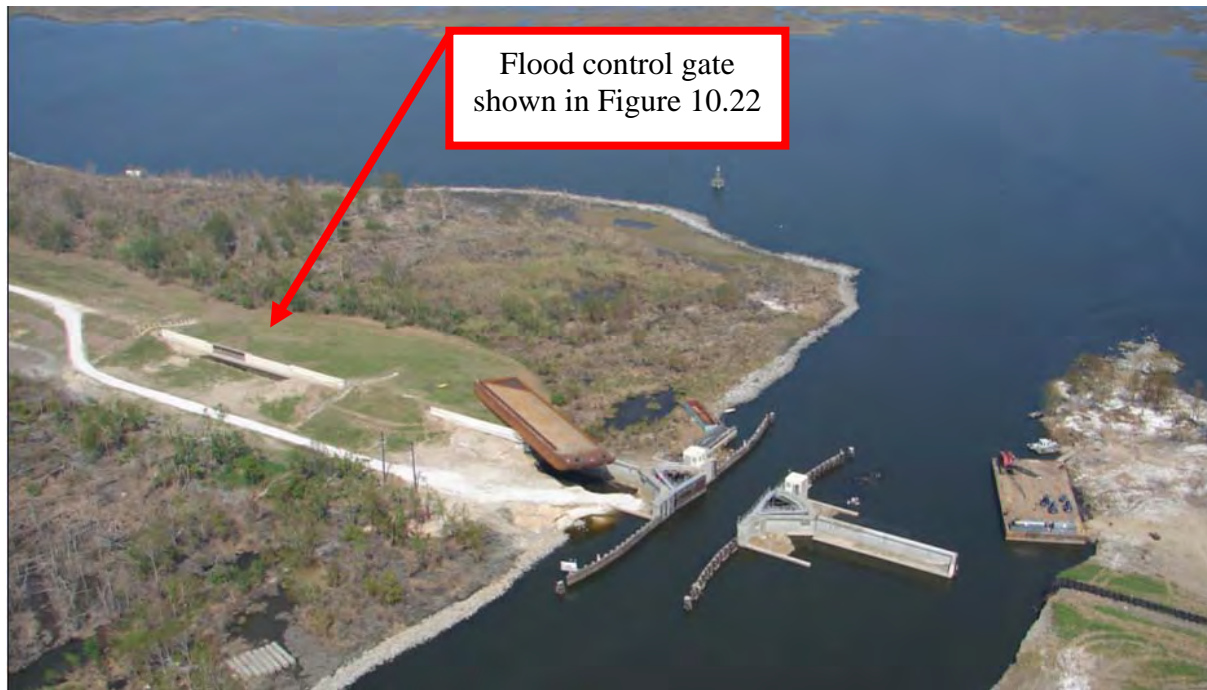
Figure 10.21: Aerial photograph of the Bayou Bienvenue Control Structure (location 7 on Figure 10.6). The northwestern half of the control structure levee system performed extremely well (withstanding significant impact loads from the steel barge), while the southeastern portion suffered severe erosion.

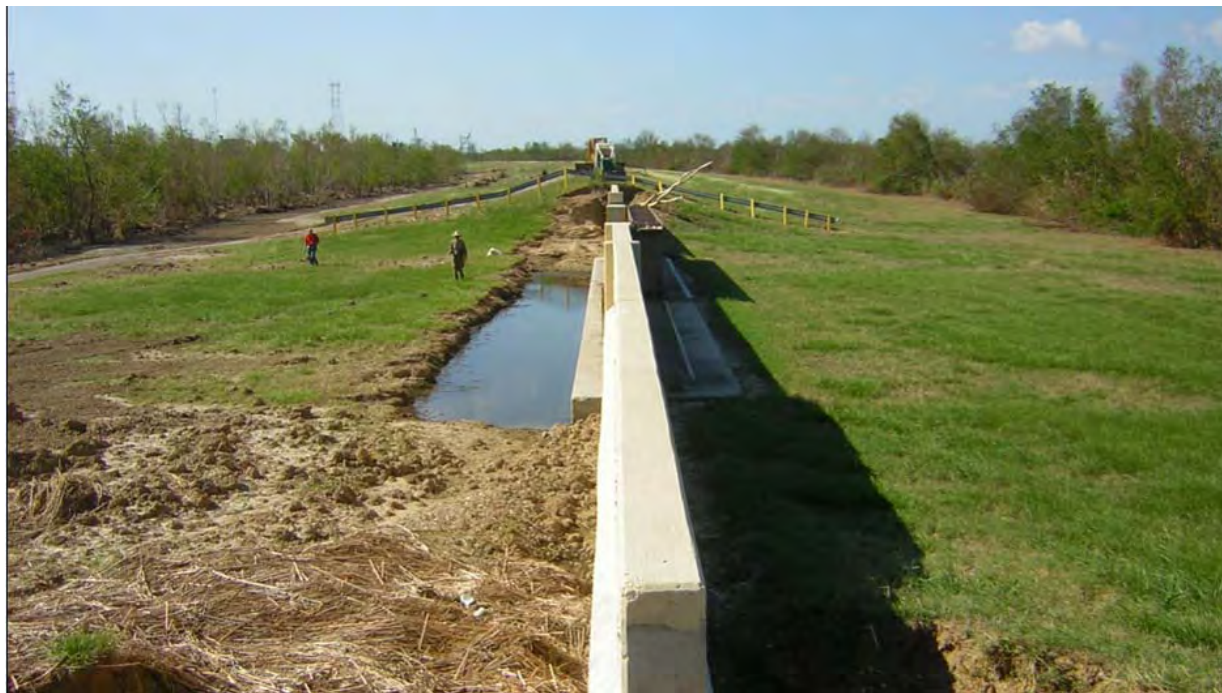
Figure 10.22: This flood control gate acted like a weir as water overtopped the structure during the storm surge. Significant scour and erosion was observed around the flood control gate structure.
